July 31, 2008

Document No. 20807001.2

Regarding: Limited Fungal Growth Assessment Survey
1ST Floor – Print Room 135

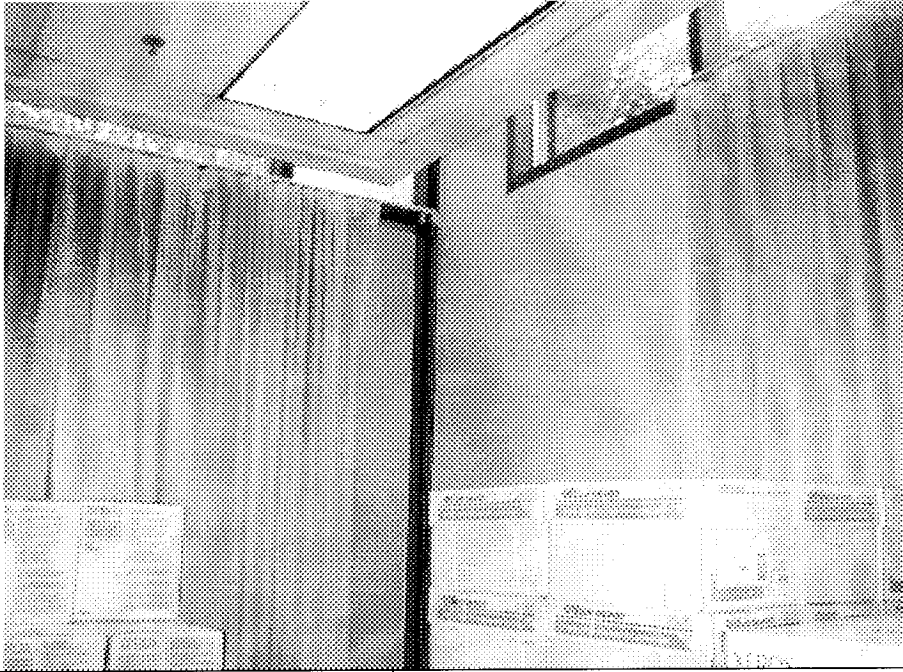
1

Date	Address	Photo Location – Description	Up
07/09/08	450 N Street Sacramento, California	First floor; Print Room 135; northeastern portion of room; looking northeast; view of northeastern corner; general view of area	↑

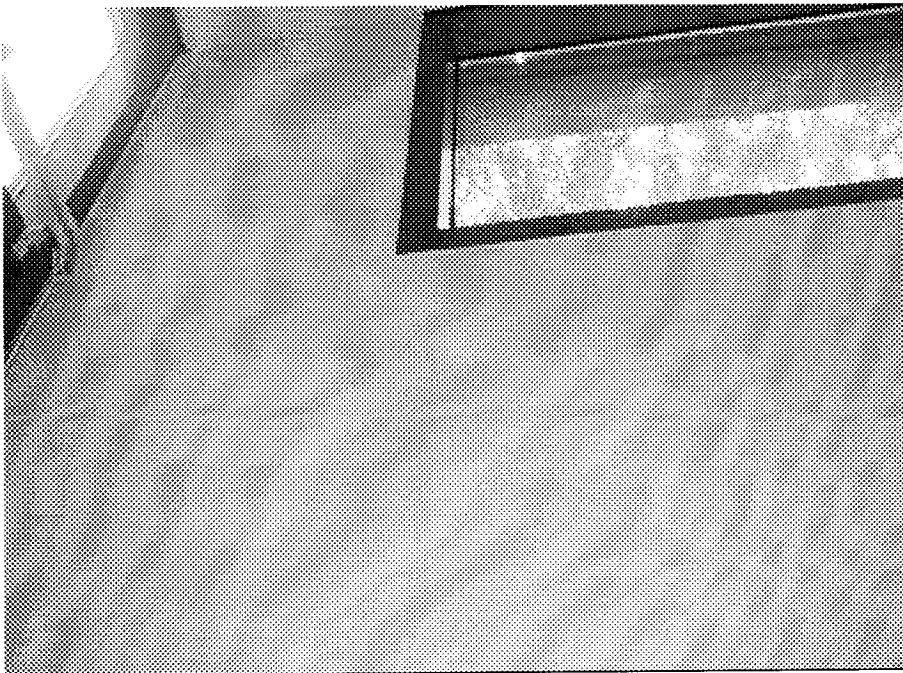
2

Upon visual inspection, evidence of water intrusion was apparent in various areas within the room. In the northeastern portion of the room, water staining was observed on the eastern perimeter wall beneath the upper and storefront windows (Photos 1 through 3). Additionally, suspect fungal growth was observed on the lower portion of the northern perimeter wall in the northeastern corner (Photo 4). Beneath the raised floor system in the subfloor area, water staining and evidence of metal oxidation (rust) were observed on various building materials along the northern and eastern perimeter walls in both the northeastern and southeastern portions of the room (Photos 5 through 12). Additionally, efflorescence was observed on the concrete subfloor at the southern portion of the room (Photo 13). Odors characteristic of fungal growth were not evident in the inspected areas.

Date	Address	Photo Location – Description	Up
07/09/08	450 N Street Sacramento, California	First floor; Print Room 135; northeastern portion of room; looking east and up; view of eastern perimeter wall; showing water staining	↑

- 1) Possible sources of the water intrusion should be identified or confirmed and the subsequent repairs made. If water intrusion occurs in the structure in the future, affected materials should be dried promptly so that fungal growth potentials are minimized.
- 2) Additional building investigative and/or remediation efforts should be performed in this room and any adjacent rooms as necessary.
- 3) All concrete surfaces beneath the raised floor system in the eastern portion of the room should be detail-cleaned with HEPA vacuum and/or other equipment, and sanitized with a suitable biocide.
- 4) Those portions of building materials showing evidence of fungal growth should be isolated using polyethylene sheeting until remediation can be performed.

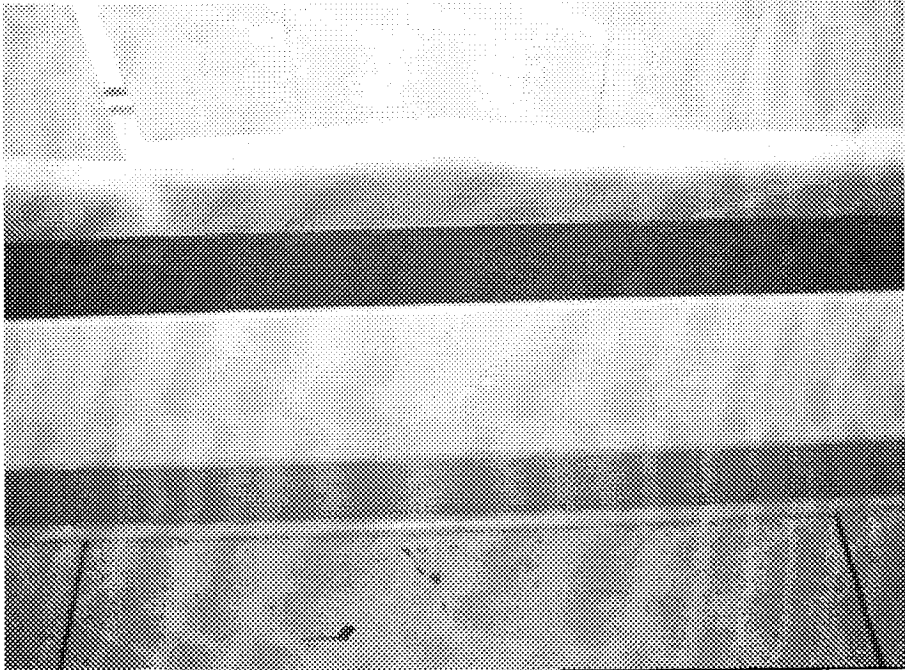
3

Date	Address	Photo Location – Description	Up
07/09/08	450 N Street Sacramento, California	First floor; Print Room 135; northeastern portion of room; looking east and down; view of eastern perimeter wall; showing water staining	↑

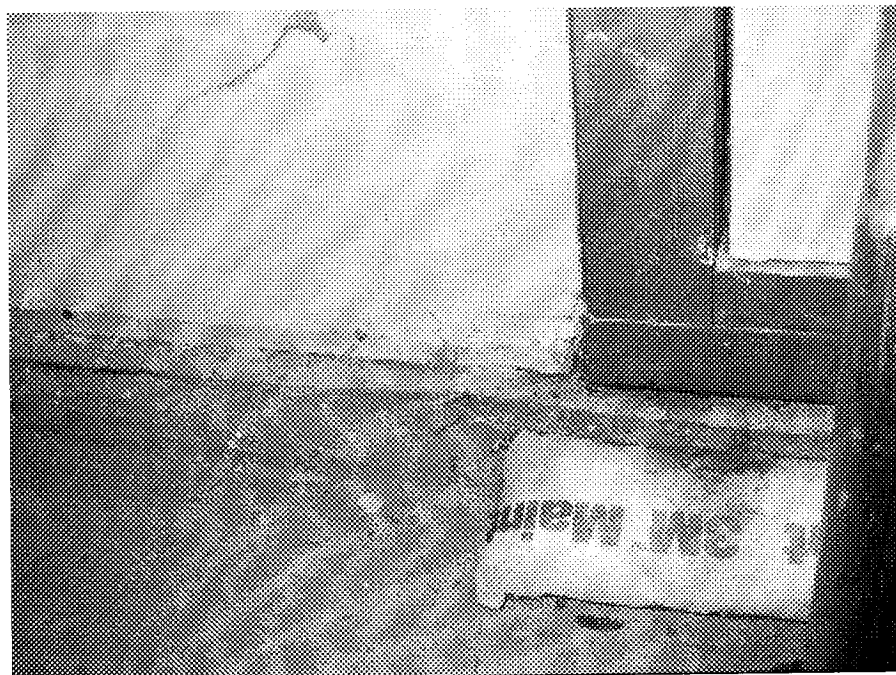
8

Date	Address	Photo Location – Description	Up
07/09/08	450 N Street Sacramento, California	First floor; Print Room 135; southeastern portion of room; looking east and down; view subfloor area beneath eastern storefront window; showing water staining northern perimeter wall and on absorbent sock	↑

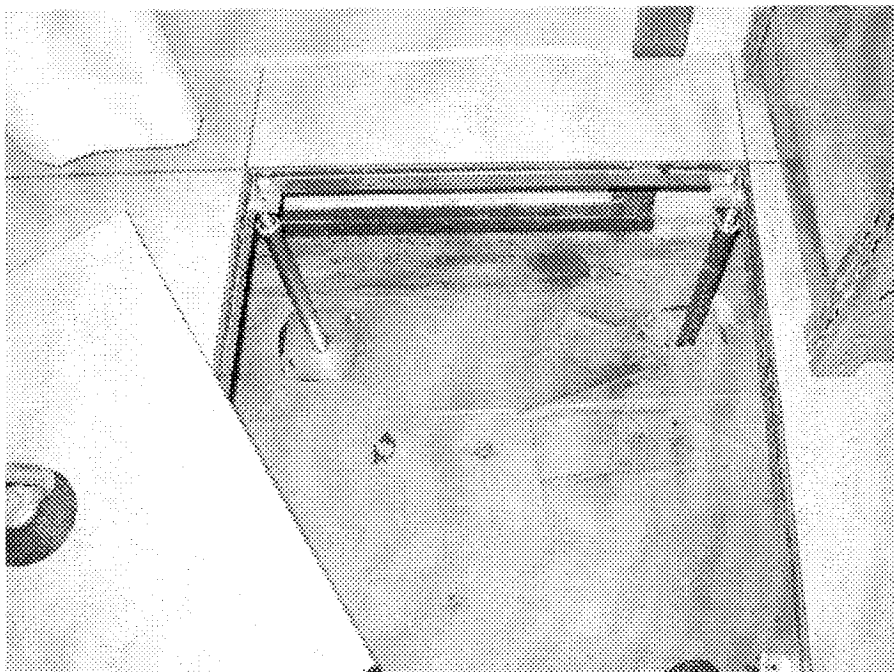
9

Date	Address	Photo Location – Description	Up
07/09/08	450 N Street Sacramento, California	First floor; Print Room 135; southeastern portion of room; looking east and down; view of subfloor area beneath eastern storefront window; showing staining on absorbent sock	↑

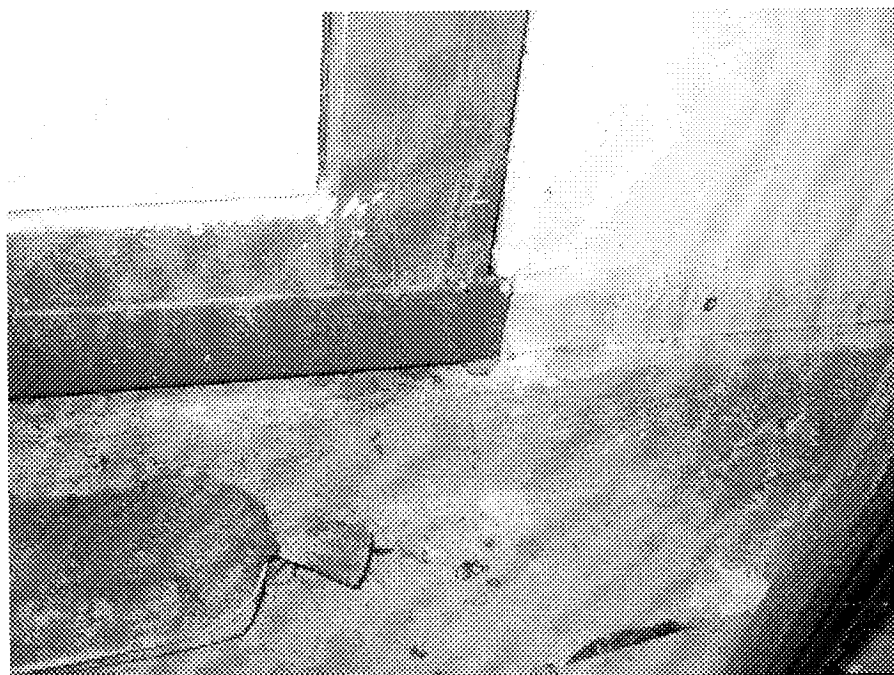
10

Date	Address	Photo Location – Description	Up
07/09/08	450 N Street Sacramento, California	First floor; Print Room 135; southeastern portion; looking east and down; view of subfloor area beneath eastern storefront window; showing water staining on absorbent sock and northern perimeter wall	↑

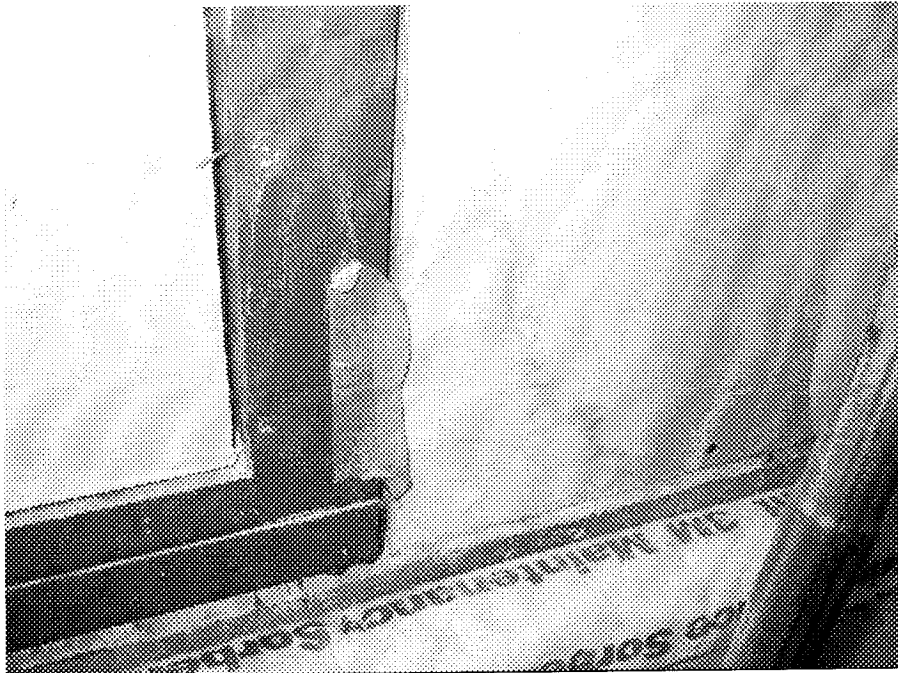
12

Date	Address	Photo Location – Description	Up
07/09/08	450 N Street Sacramento, California	First floor; Print Room 135; southeastern portion of room; looking east and down; view of subfloor area beneath eastern storefront window; showing staining on eastern perimeter wall	↑

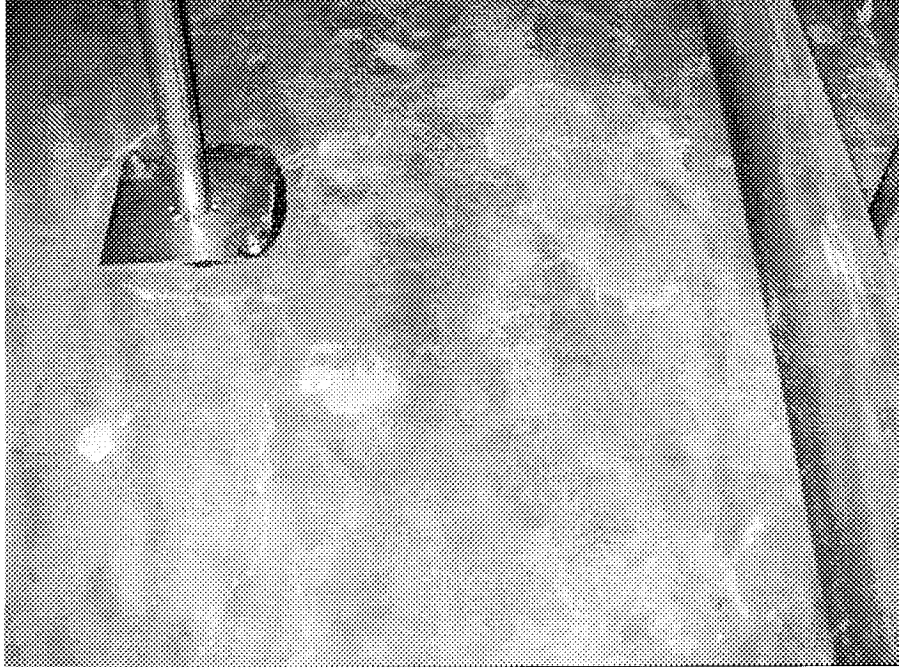
Date	Address	Photo Location – Description	Up
07/09/08	450 N Street Sacramento, California	First floor; Print Room 135; southern portion of room; looking down; view of southern portion of subfloor area; showing staining and efflorescence on concrete subfloor	↑
